Chlorinated Solvent Plume: A Case Study

Stuart Manley

April 4, 2019

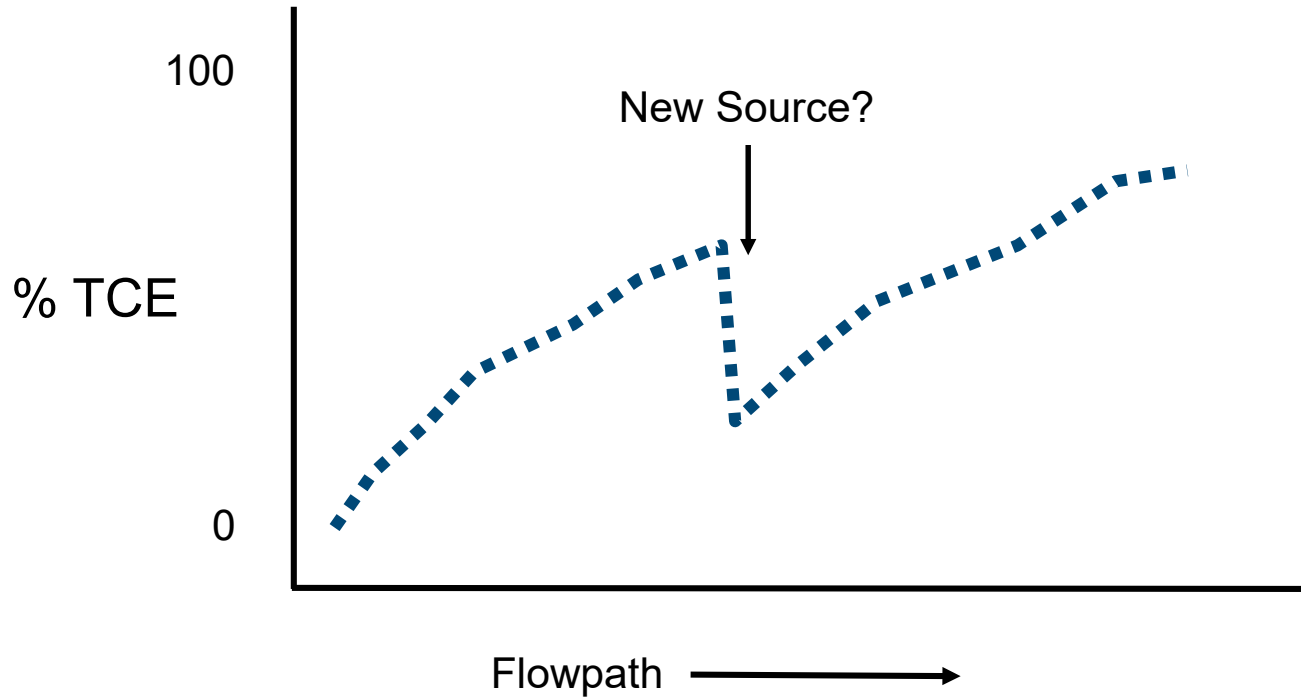
Concentration Ratios Along the Flowpath

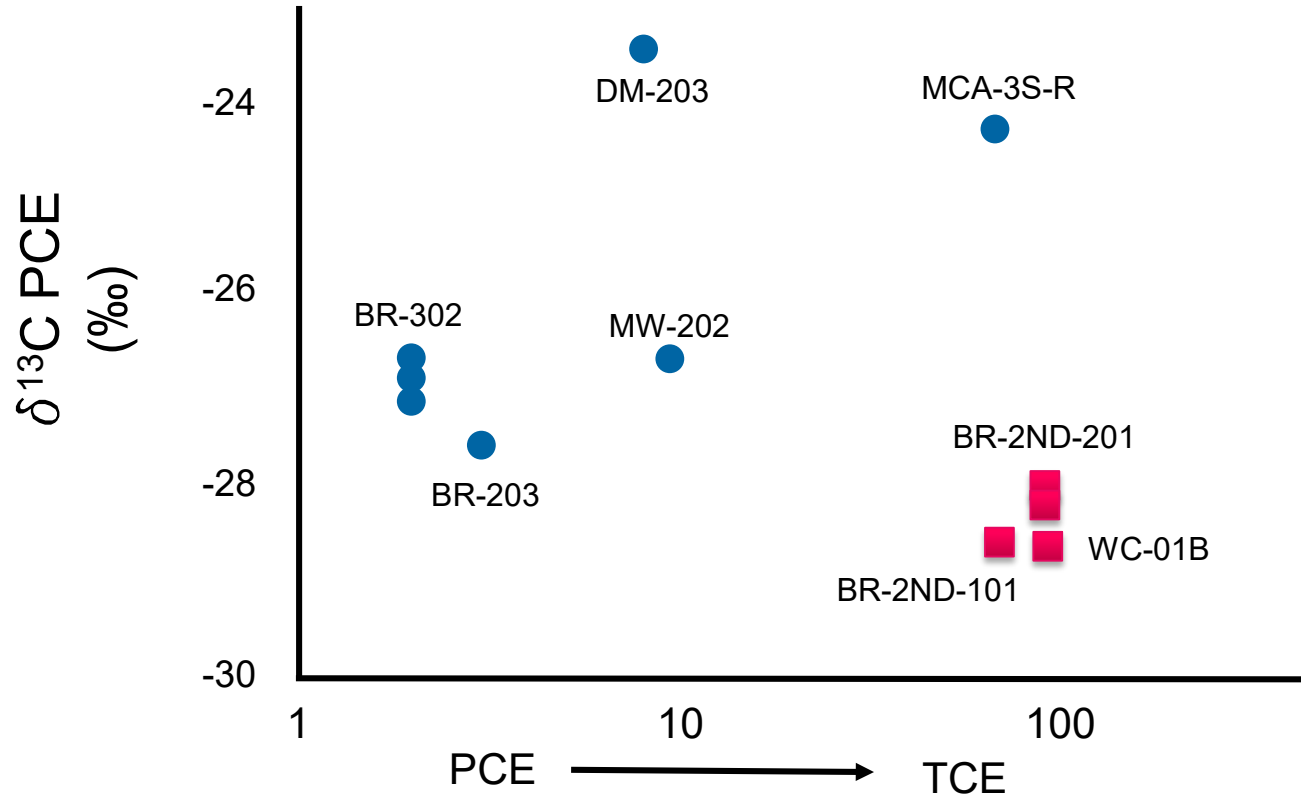
Isotope Results $^{13}\text{C}_{\text{PCE}}$

Well	PCE - $\delta^{13}\text{C}$ ‰	PCE - $\delta^{37}\text{Cl}$ ‰	TCE - $\delta^{13}\text{C}$ ‰	TCE - $\delta^{37}\text{Cl}$ ‰	PCE $\mu\text{g/L}$	TCE $\mu\text{g/L}$
BR-203	-27.5	-0.35	-37.7	-0.74	9,800	240
BR-302	-26.8	-0.18	-42.1	-2.07	3,300	51
MW-202	-26.8	-0.22	-26.3	0.91	640	53
DM-203	-23.0	-0.19	-27.0	1.19	360	24
MCA-3S-R	-24.2	BQL	-26.2	1.99	9.6	22
WC-01B	-28.6	BQL	-23.6	-0.81	1.7	36
BR-2ND-101	-28.6	BQL	BQL	-1.45	7.5/7.5	14/12
BR-2ND-202	-28.0	BQL	BQL	BQL	1.1/ND	9.1/2.8

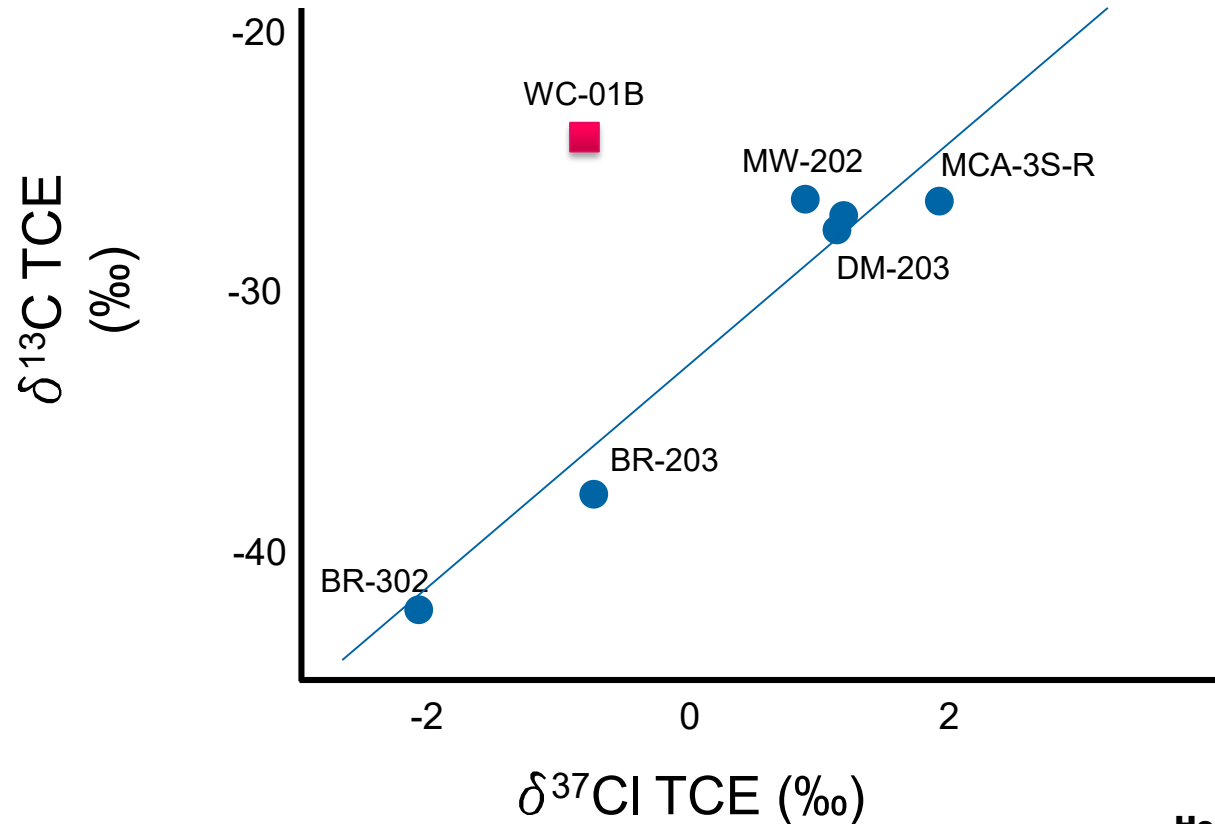
^{13}C and ^{37}Cl for TCE

- Multiple lines of evidence used to demonstrate that a secondary TCE plume is present
- Delineation: Complete!
- Able to submit updated Phase III CSA and move into remedy phases

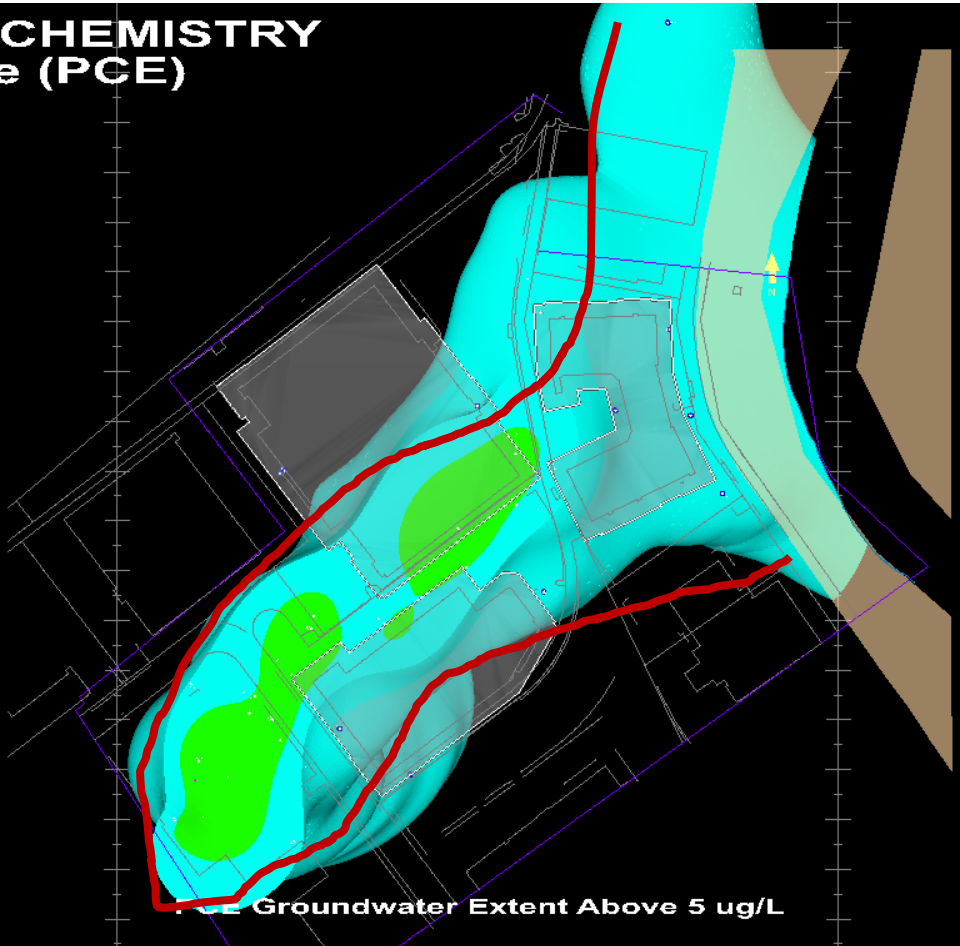
GROUNDWATER CHEMISTRY Tetrachloroethene (PCE)

[March 2018]

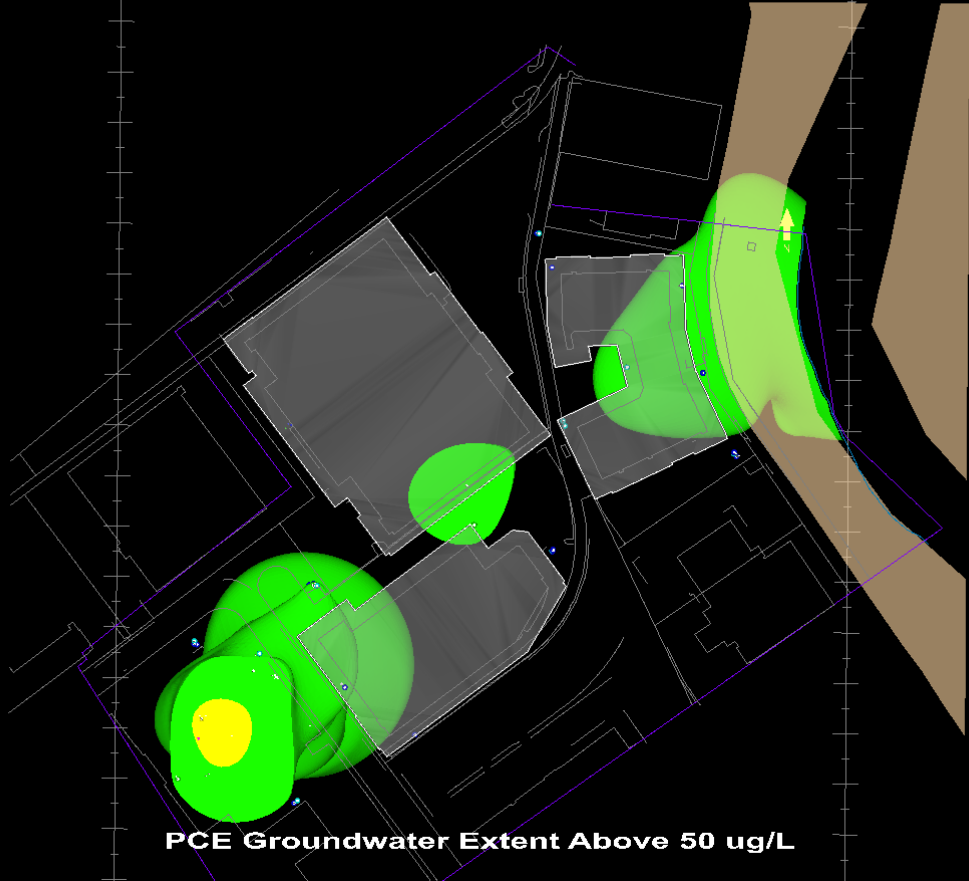
GROUNDWATER CHEMISTRY Tetrachloroethene (PCE)

[November 2018]

PCE Groundwater Extent Above 50 ug/L

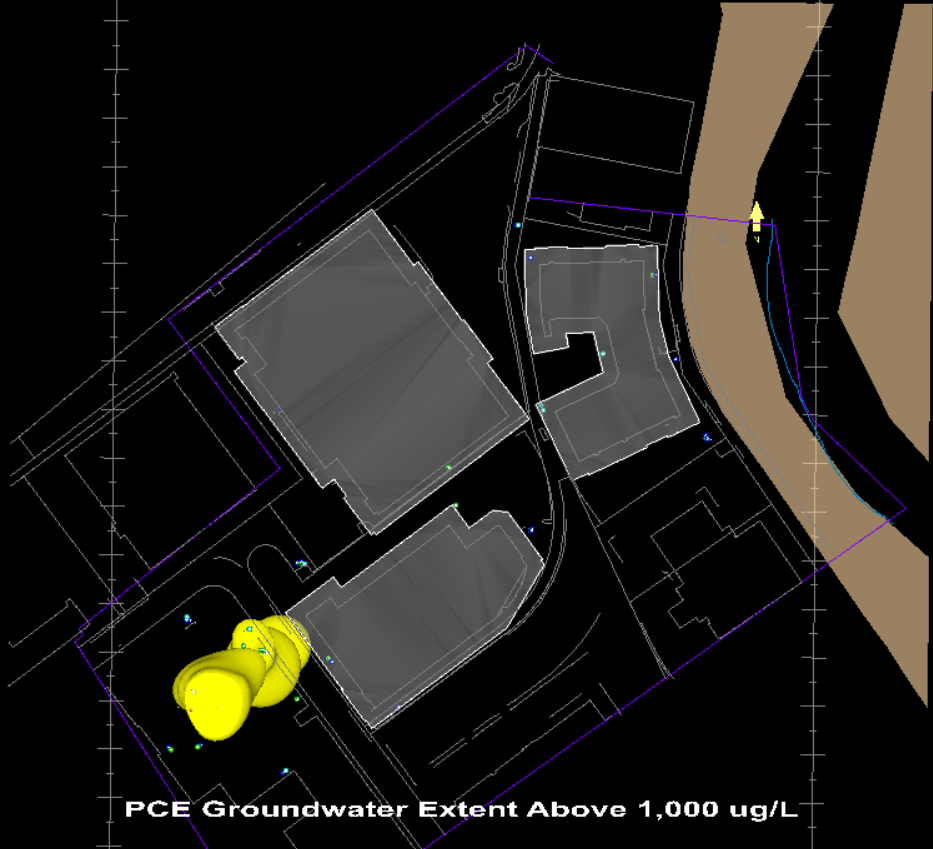
GROUNDWATER CHEMISTRY Tetrachloroethene (PCE)

[November 2018]

PCE Groundwater Extent Above 1,000 ug/L
